1994

CONSTRUCTION OF BREAKWATERS AND BEACHFILL
AT THE NAVAL AIR STATION, PATUXENT RIVER, MARYLAND

D.W. Yang¹, J. McWilliams², S. Ming²

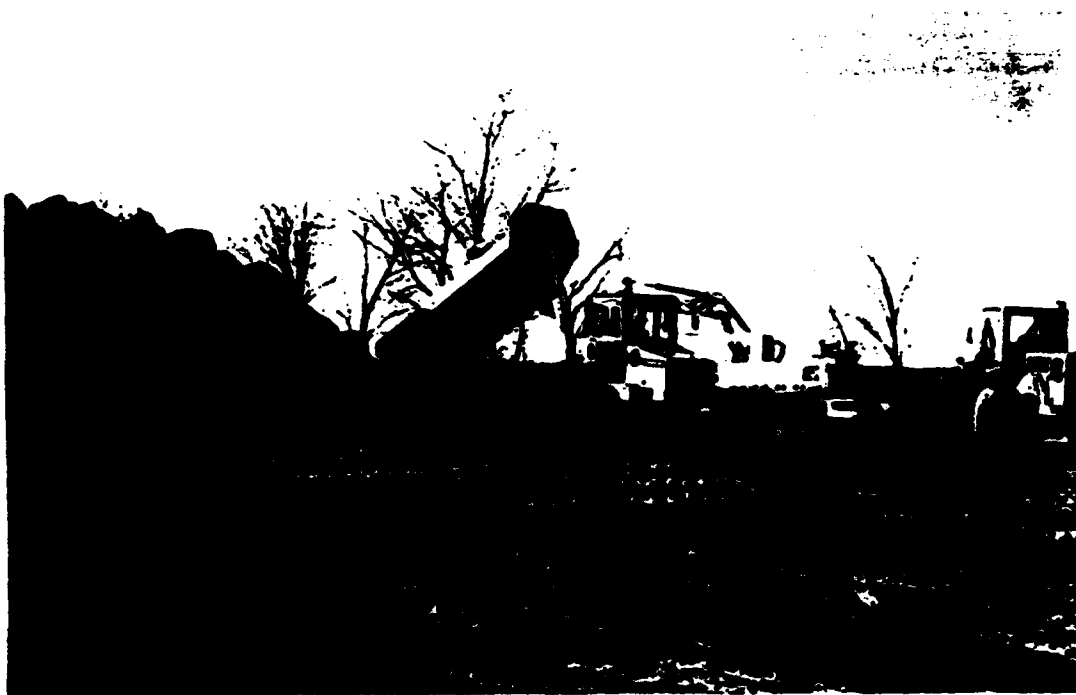
Figure 7 Rock Stockpile

Major construction material for this project included approximately 12,000 tons of armor rock, 4,000 tons of core stone and 25,000 cubic yards of sand. The rock materials were delivered via barge from the quarry source located at Havre de Grace, Maryland (on the Susquehanna River), approximately 90 miles north of the site. The barges, containing approximately 550 ton of armor rock per load, were unloaded by a barge-mounted crane equipped with a clamshell bucket into Volvo Penta A20 dump trucks and transported to the stockpile (Figures 6, 7).

At the stockpile, the contractor used a smaller backhoe equipped with a grapple to segregate smaller stones from the pile. The contractor endeavored to use the largest stones on the breakwater toes and armor layers. However, stones with weights less than 2,700 lbs. were inevitably placed in the armor layers to facilitate breakwater construction, since the project was conducted in the winter and time was of the essence. The small stones were removed and replaced with larger stones upon completion of initial construction of the breakwaters.

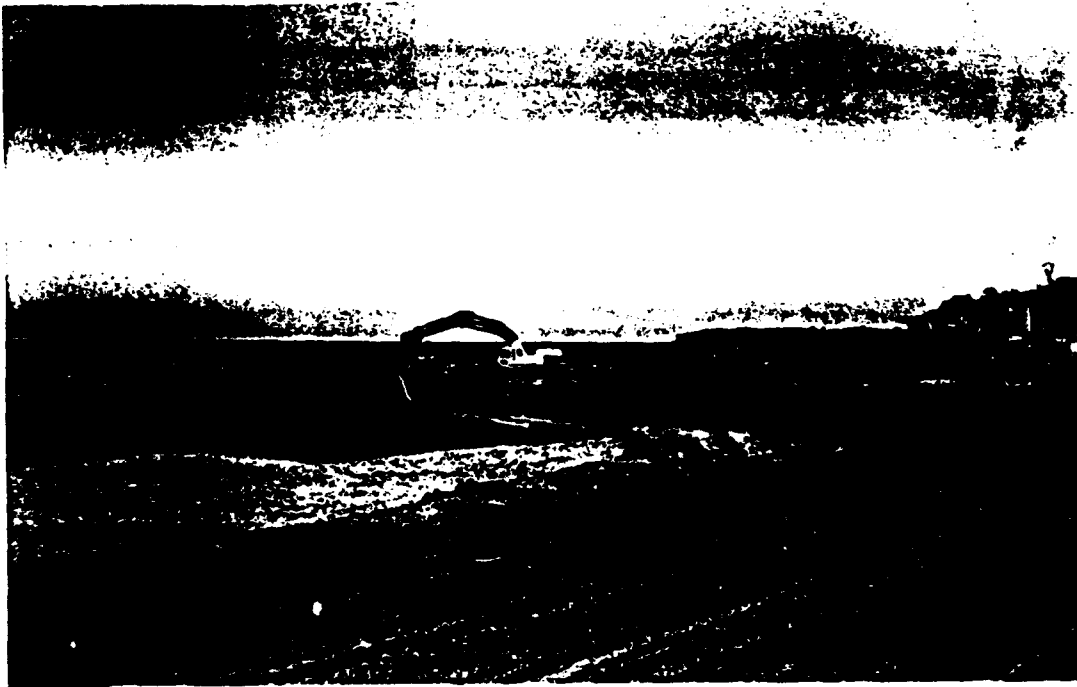
Figure 8 Spreading Beach Fill

The beach fill material was delivered via 12 cubic yard dump truck or 36 cubic yard truck trailer from the sand pit located 5 to 6 miles from the construction site. Approximately 2,000 truck loads were delivered to the site via the service road and stored at several temporary piles. The sand was spread on beach with using front end loaders and bulldozers (Figure 8).

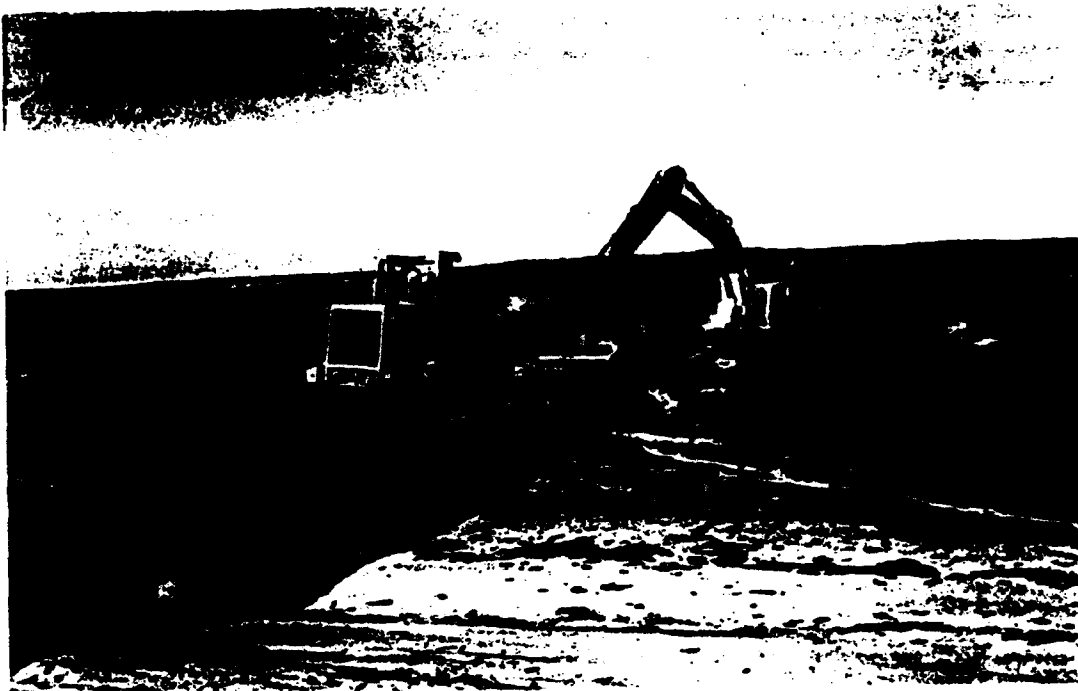
Figure 9 Temporary Causeway

The single shore-connected and five segmented breakwaters were constructed using land-based equipment including a Link Belt LS 5800 backhoe for stone placement, a Caterpillar front end loader for stone transport, and a Link Belt backhoe with grapple for loading stone. To reach the offshore breakwater sites, temporary causeways were built using the sand fill material from the existing shoreline to the breakwater sites (Figure 9).

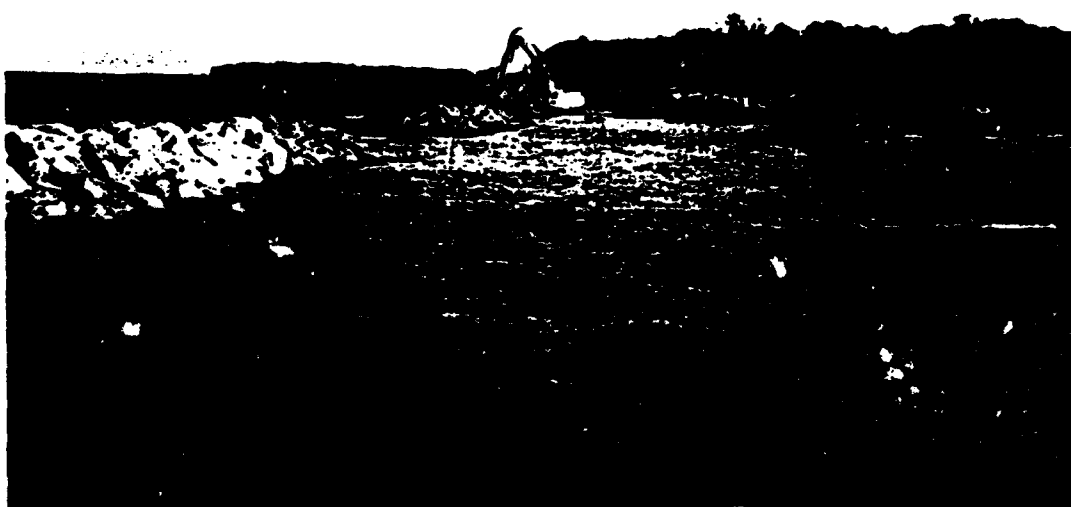
Figure 10 Armor Placement

The foundation of the breakwater was prepared by placing geotextile fabric on the existing sandy bottom, anchored by armor units around the toe. Core stone was placed on top of the filter fabric to a thickness of 36", a change suggested by the contractor and approved by the designer. The armor and core stones were transported to the breakwater site from the armor stockpile via the front end loader. The rock was dumped into a steel containment bin located at the end of causeway, then picked up and set in place with the backhoe. The armor stone was manipulated in place and compacted to leave minimum voids and maximum contact between each armor unit (Figure 10). The final rubblemound slopes, crest widths, elevations and lengths were checked by topographic surveys performed by both the Contractor and Frederic R. Harris, Inc.

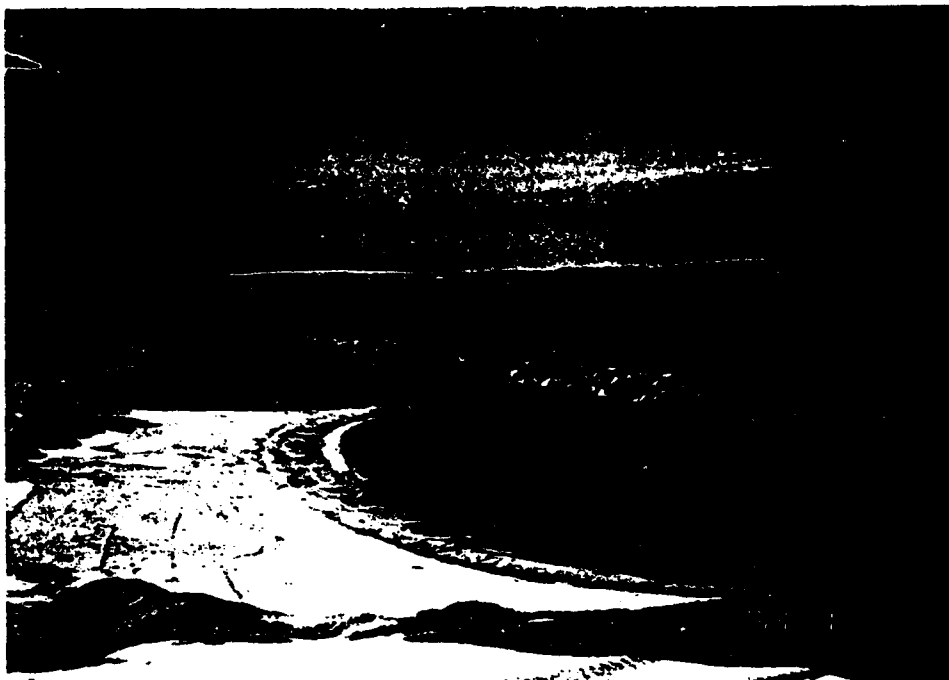
Figure 11 Completed Shoreline Looking West

Final beach fill placement and grading operations were conducted after all six breakwaters were in place. The berm was filled to +6 feet MLW to a crest line approximately 121 feet leeward from the centerline of the offshore breakwaters and maintaining a 1 vertical on 10 horizontal beach slope. Filter fabric was placed against the leeward slope and toe of the shore connected breakwater to prevent seepage of sand through the voids. Immediately after the beach fill was placed, a salient formation of the shoreline was observed. Figure 11 and 12 illustrates the post-construction conditions.

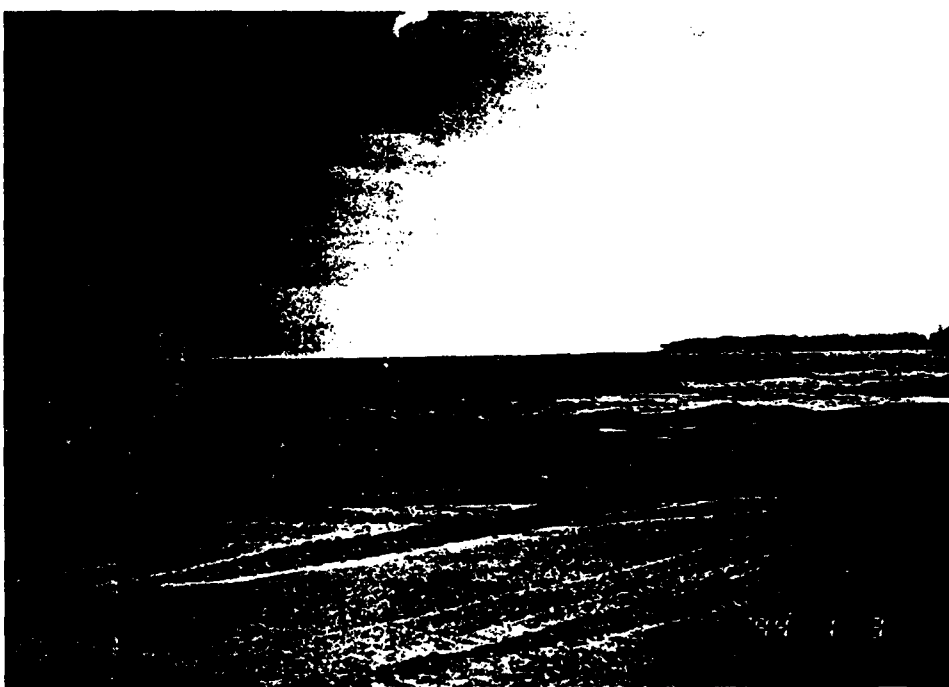
Figure 12 Completed Shoreline Looking East
